concrete openings

THE OFFICIAL MAGAZINE OF CSDA

Utility and Sewer Lines Located
Using Imaging Technology

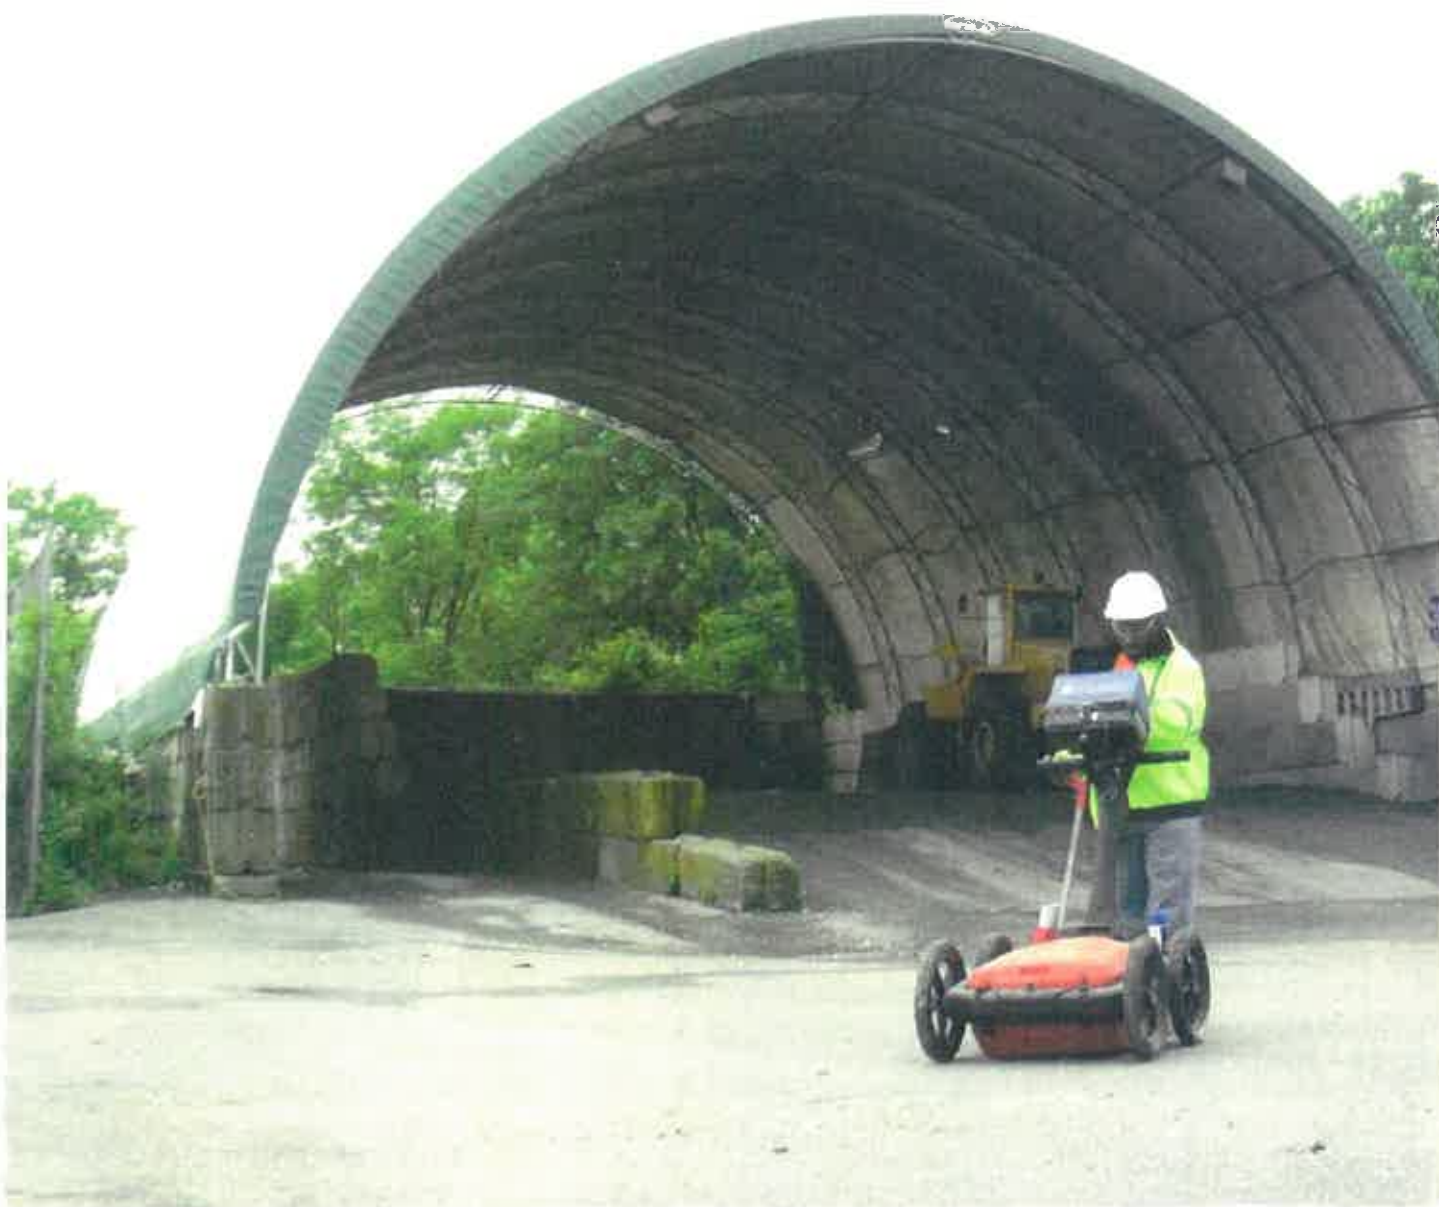
Opposite Page:
GPR imaging and utility detection helped to identify hidden objects beneath soil, concrete and asphalt.

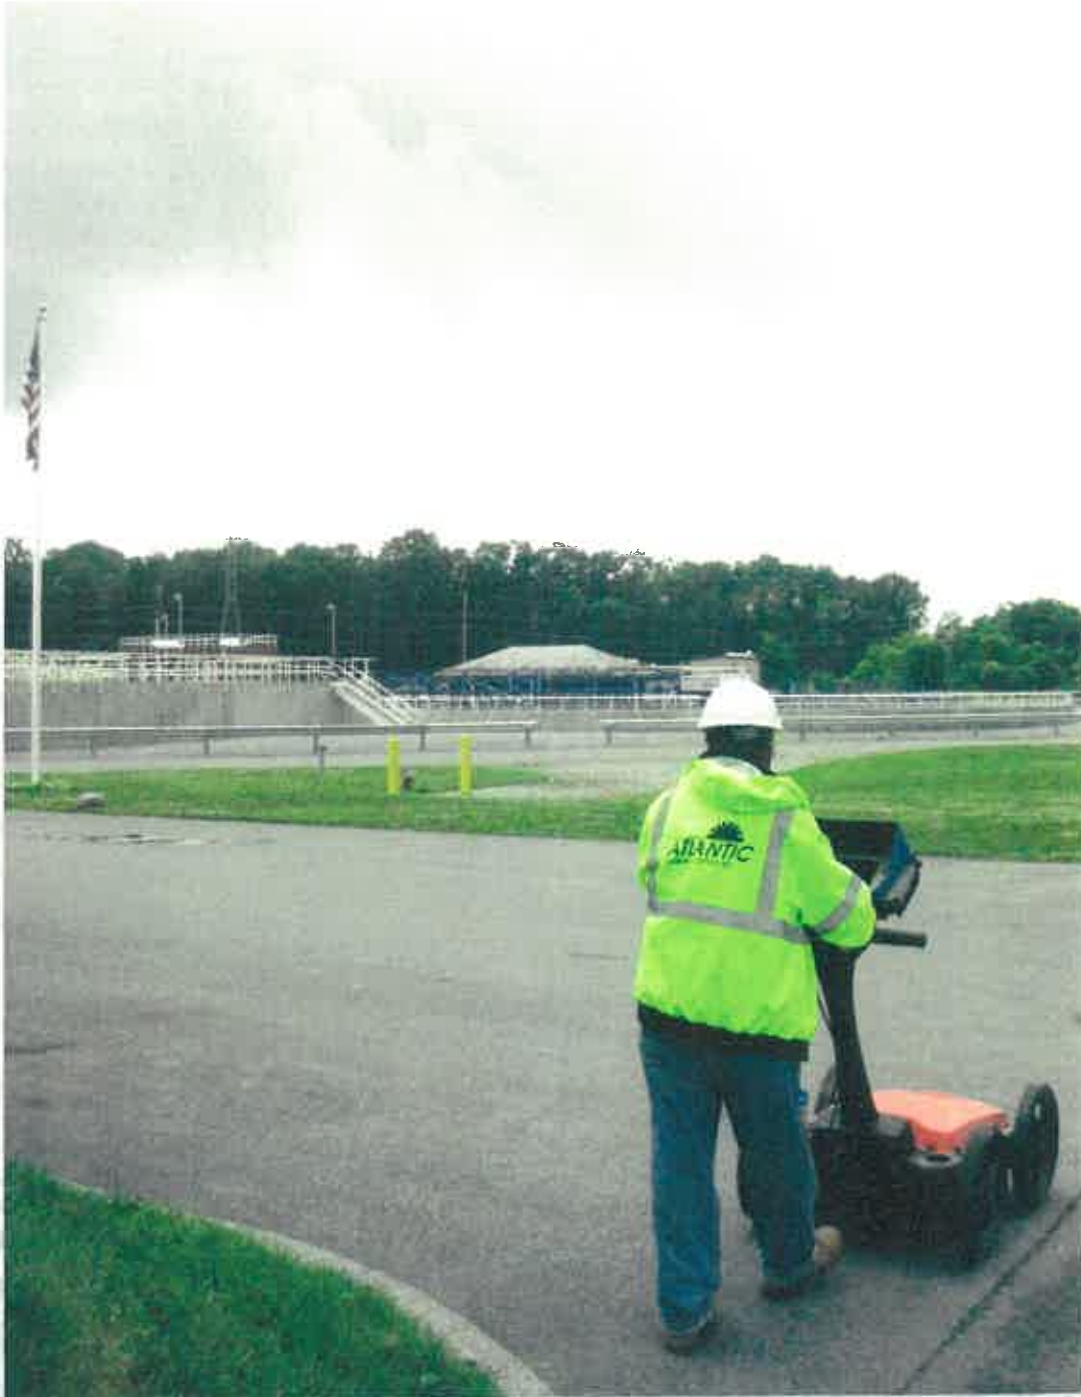
Operators scanned 9,670 linear feet of surface in the specified areas.

Atlantic Subsurface Imaging completed all imaging work in three work days, performing 9,670 linear feet (approximately 1.8 miles) of surface imaging over various materials. This was a successful project for the contractor, finishing all work within budget and on time.

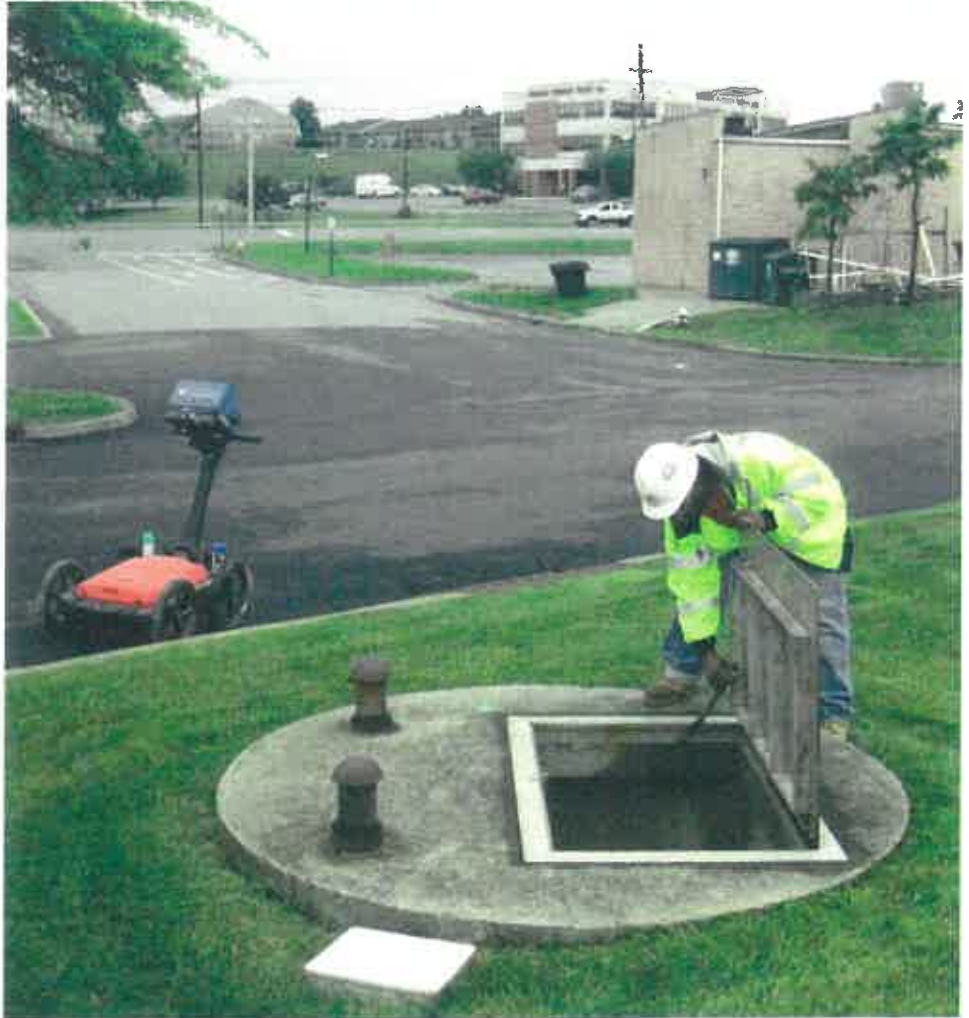
The equipment was used to cover an average of 460 feet per hour.

The team from Atlantic Subsurface Imaging used a SIR 3000 GPR unit with 400 and 270 MHz antennas supplied by CSDA member Geophysical Survey Systems, Inc. (GSSI) to identify non-metallic utilities. This included sewer lines and other unknown subsurface obstructions. Any unknown obstructions detected by the GPR equipment were identified by a mark of fluorescent spray paint on the surface. An operator moved the unit between points, covering an average of 460 feet each hour and at depths of up to 8 feet below the surface.

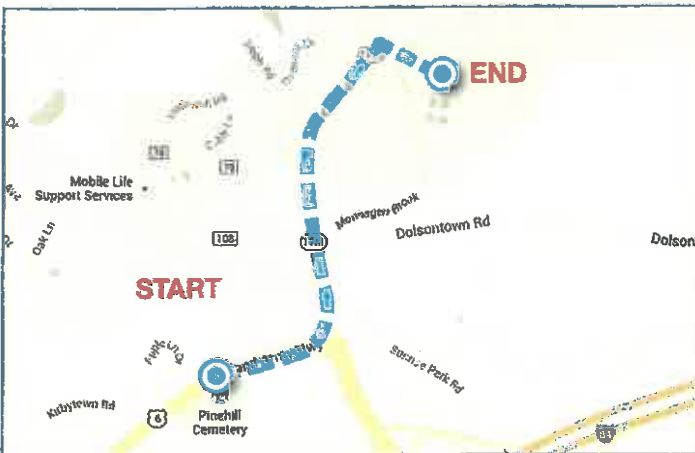
Map of the scanning/imaging route

The locating of utilities started at a proposed sewer pump station approximately 2,000 feet west of an intersection at Route 6 and Route 17M. From there, the proposed route took the team north and led them to the grounds of the City of Middletown Wastewater Treatment Facility. The route was planned so that work began at the location of the proposed sewer pump station. This was because this area had the least amount of traffic and buildings. There were 11 manholes along the route, which the contractor accessed to confirm some utility runs. It was specified that ASI would locate and mark out underground utilities from curb to curb and 15 feet beyond each side, all within the New York Department of Transportation’s

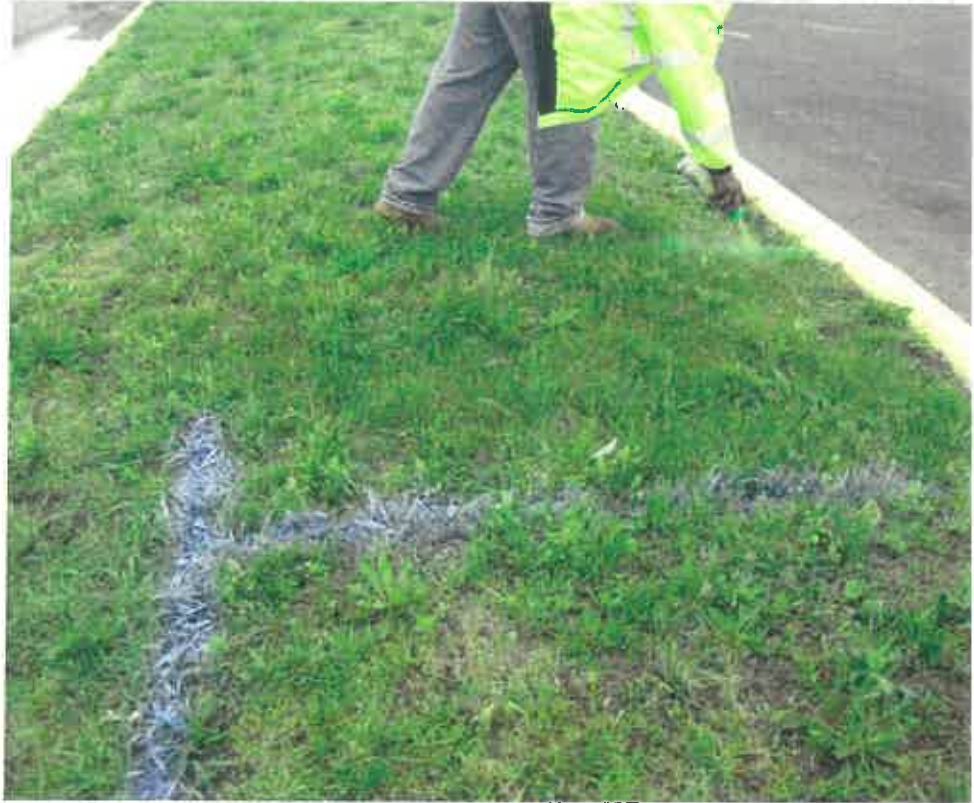
All electrical, gas, telephone, sewer and water lines were identified with APWA uniform color codes.

A utility locator from Vivax-Metrotech was used to identify and map out existing property utility services to the main supply. Each utility service and main was identified on the surface using spray paint in accordance to The American Public Works Association (APWA) Uniform Color Codes.

Color	Utilities
RED	Electric power lines, cables, conduit and lighting cables
ORANGE	Telecommunication, alarm or signal lines, cables or conduit
YELLOW	Natural gas, oil, steam, petroleum or other gaseous or flammable material
GREEN	Sewer and drain lines
BLUE	Water

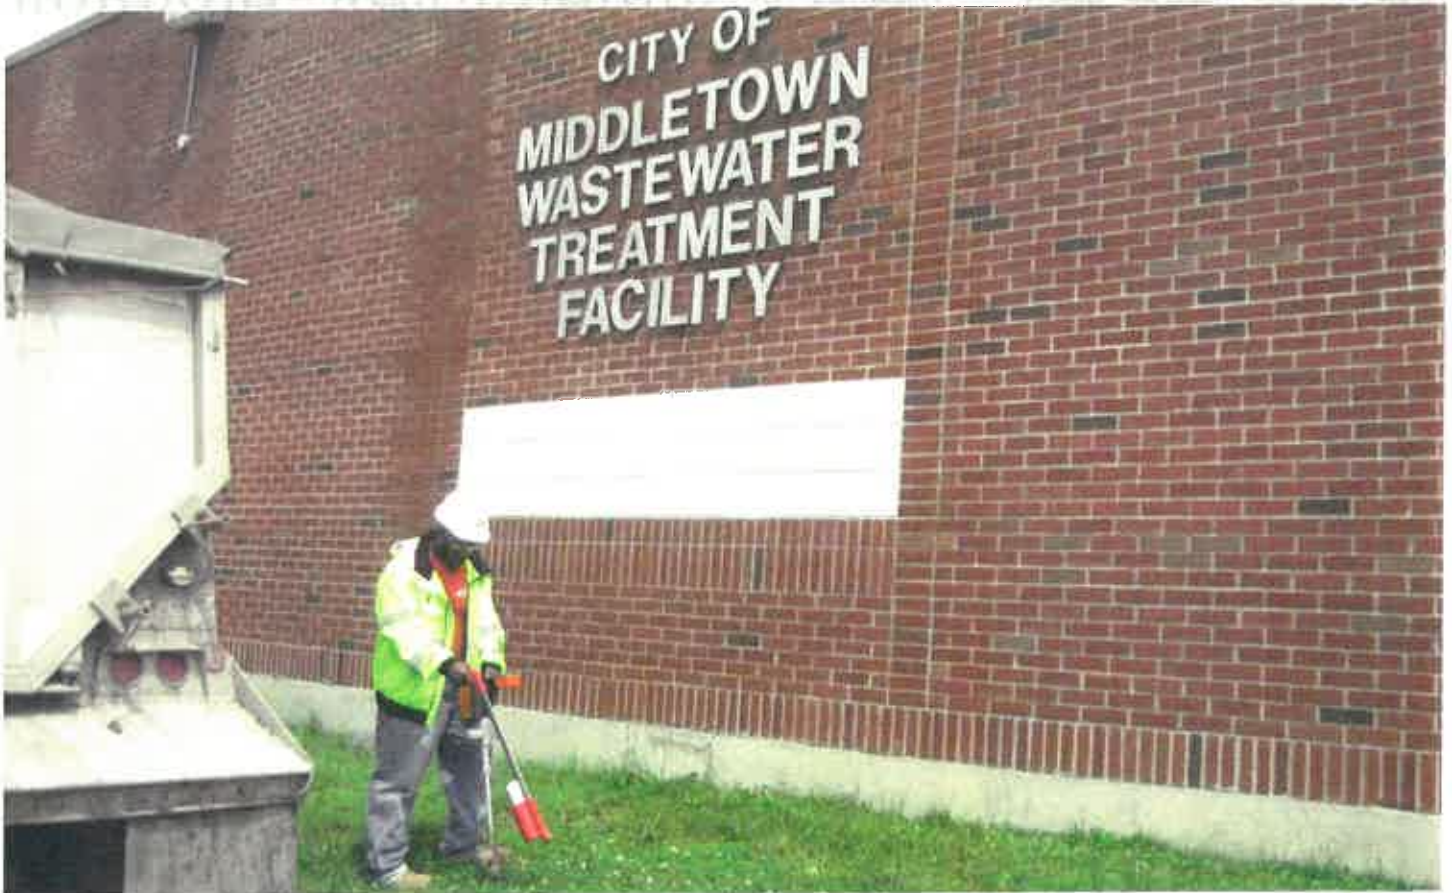
The results have helped engineers with the design of a new sewer system.

The findings of this contractor's scanning work have provided the City of Middleton with key information that will help engineers form a strategy for the installation of a new sewer system. The use of GPR and utility locating equipment helped to determine what was beneath the surface, making sure the design phase of this new project can be completed as accurately as possible.
